AMERICAN BUREAU OF SHIPPING

Structural Failures in

Liberty Vessels

Reported to February 15, 1944

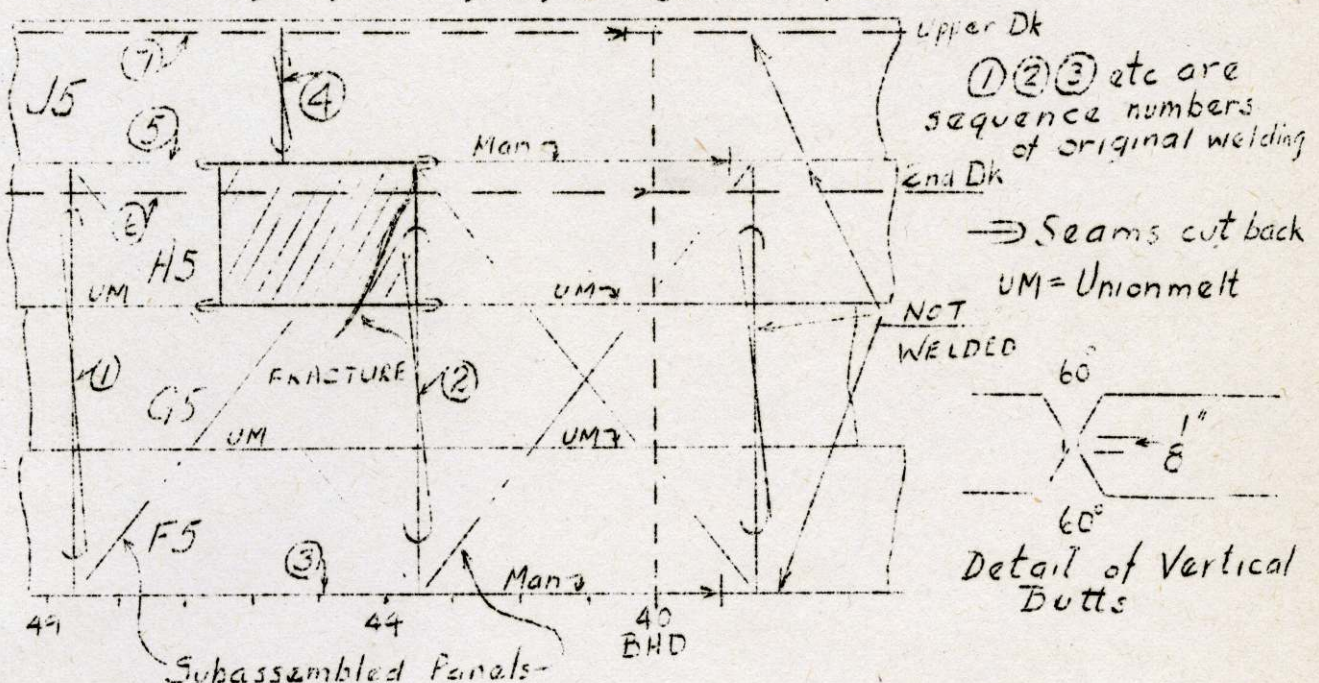
Fracture started in welded butt, then progressed down. Some lack of fusion in butt.

Tensile specimens taken from H5 in vicinity of crack showed ultimate 60,000, YP 35,000, elongation 25% in 8".

Method of repair: Shaded area is new portion of plate fitted. Seams and 2nd deck released 12" each side of butts. Fracture in G5 veed and welded. New plate welded as follows: after butt, forward butt, top seam, bottom seam, 2nd deck to shell. Forward butt and both seams peened. All welds back stepped.
