AMERICAN BUREAU OF SHIPPING

Structural Failures in

Liberty Vessels

Reported to February 15, 1944

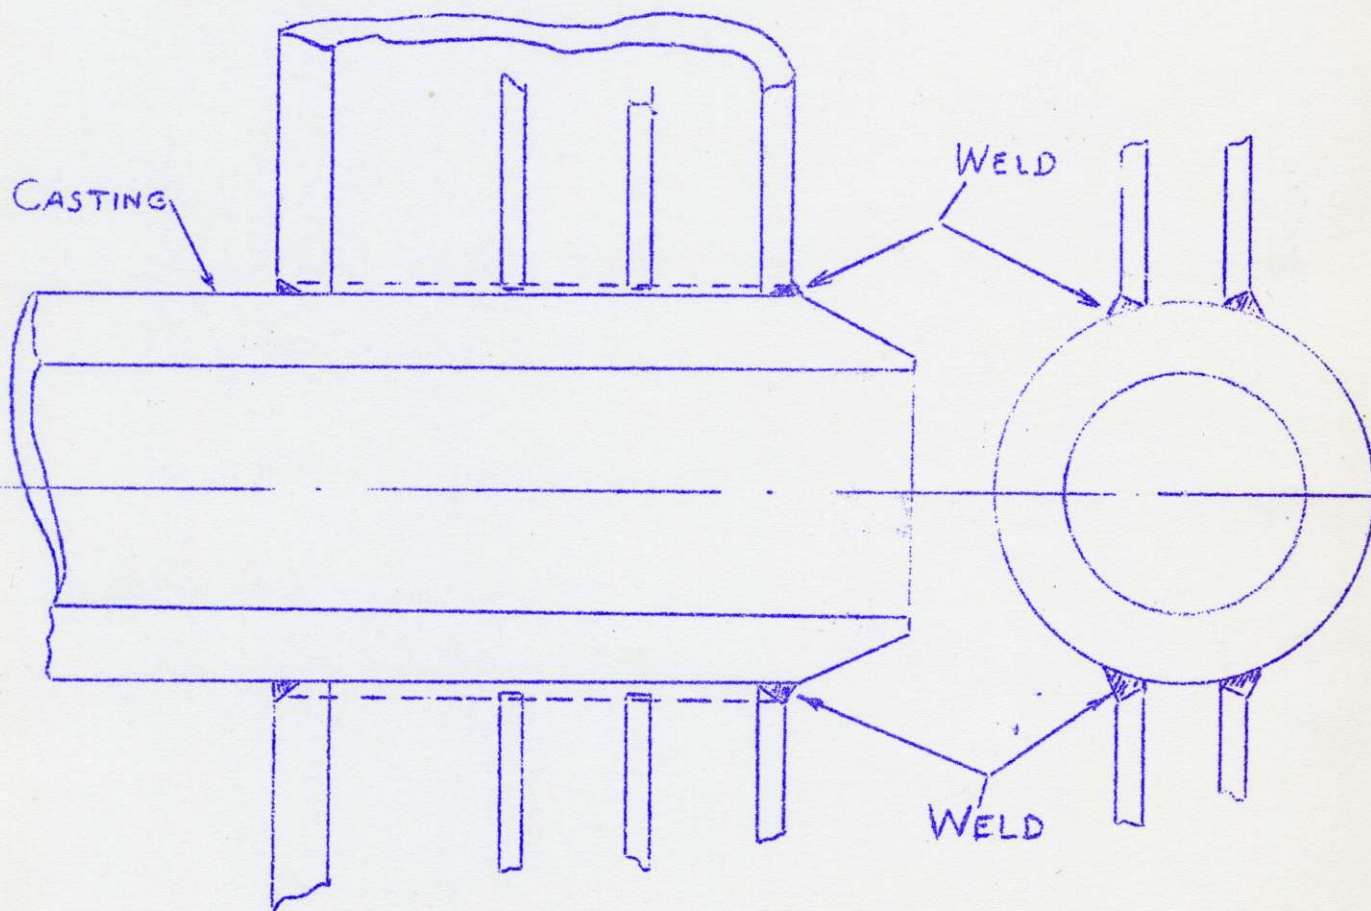
SECTION THRU ARM

The strut was being welded to the hub in the shop at temperature of about 500°. The joint was properly v'd out the first passes of welding were laid-in and peened. The welding fractured, was cut out and the performance repeated with the same result of fractured welds.

The contractors then cut out all the welding and heated the hub with flame heat until same was quite hot. The welding then proceeded as before with no further evidence of fractures and was again examined after all the metals had cooled down and appeared to be a very satisfactory weld.
